# **Traffic Calming, Welton and Melton, East Riding of Yorkshire**

## **Final Report**

19<sup>th</sup> December 2012

### **CA Traffic Solutions LLP**

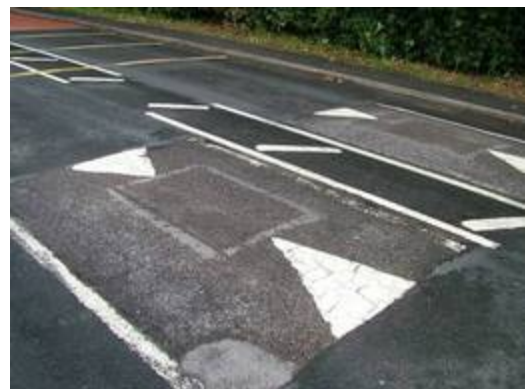
Located approximately 140 metres west of the Melton Bottom / Melton Old Road traffic-signalised junction. The southern cushion measures 2.9 metres long by 2.1 metres wide with a maximum upstand of 115 mm and the northern cushion measures 2.9 metres long by 1.9 metres wide with a maximum upstand of 80 mm and the gap between the two cushions is 1.0 metre. The gap between the southern footway and the southern cushion is 1.0 metres and the gap between the northern footway and the northern cushion is 1.0 metres. The kerb height of the southern footway is 75 mm and the northern footway is 100 mm.

February 2012 condition survey comments: [Gouge to southern plateau otherwise OK.](#)

October 2012 condition survey comments: [Replace southern plateau, renew markings.](#)

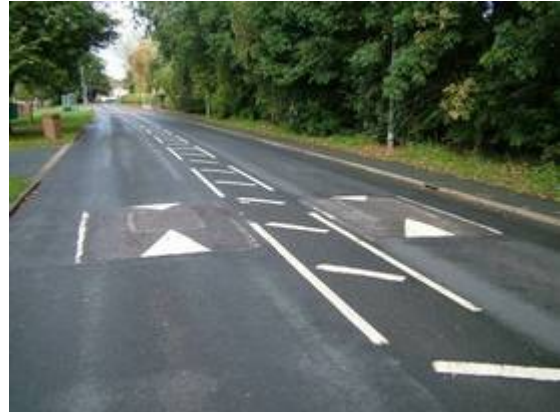
Located approximately 35 metres west of Site 1. The southern cushion measures 2.9 metres long by 2.0 metres wide with a maximum upstand of [115 mm](#) and the northern cushion measures 2.9 metres long by 1.9 metres wide with a maximum upstand of 95 mm and the gap between the two cushions is 1.2 metres. The gap between the southern footway and the southern cushion is 1.1 metres and the gap between the northern footway and the northern cushion is 1.2 metres. The kerb height of the southern footway is 90 mm and the northern footway is 100 mm.

February 2012 condition survey comments: [Eroded edge replace southern.](#)

October 2012 condition survey comments: [Eroded edge replace southern.](#)

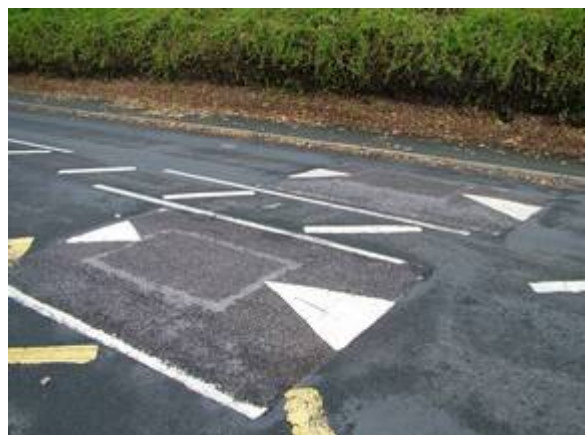
Located approximately 120 metres west of Site 2. The southern cushion measures 2.9 metres long by 2.0 metres wide with a maximum upstand of [115 mm](#) and the northern cushion measures 2.9 metres long by 2.0 metres wide with a maximum upstand of [110 mm](#) and the gap between the two cushions is 1.1 metres. The gap between the southern footway and the southern cushion is 1.1 metres and the gap between the northern footway and the northern cushion is 1.1 metres. The kerb height of the southern footway is 100 mm and the northern footway is 90 mm.

February 2012 condition survey comments: [Eroded edge replace southern.](#)

October 2012 condition survey comments: [Eroded edge replace southern.](#)

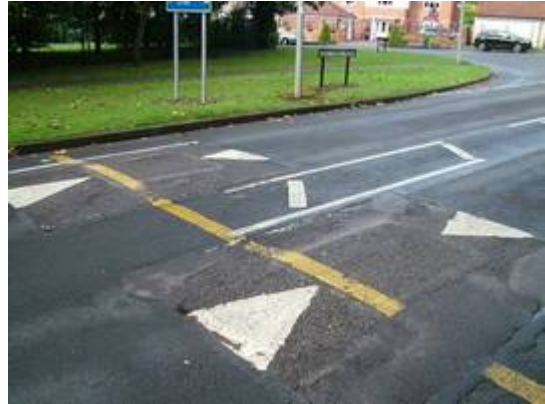
Located approximately 100 metres west of Site 3. The southern cushion measures 2.8 metres long by 2.2 metres wide with a maximum upstand of 100 mm and the northern cushion measures 2.8 metres long by 2.1 metres wide with a maximum upstand of 80 mm and the gap between the two cushions is 1.1 metres. The gap between the southern footway

and the southern cushion is 1.0 metres and the gap between the northern footway and the northern cushion is 0.8 metres. The kerb height of the southern footway is 125 mm and the northern footway is 90 mm.

February 2012 condition survey comments: [Eroded edge replace northern.](#)  
[Gouge to southern plateau otherwise OK.](#)

October 2012 condition survey comments: [Replace northern, gouges to southern.](#)

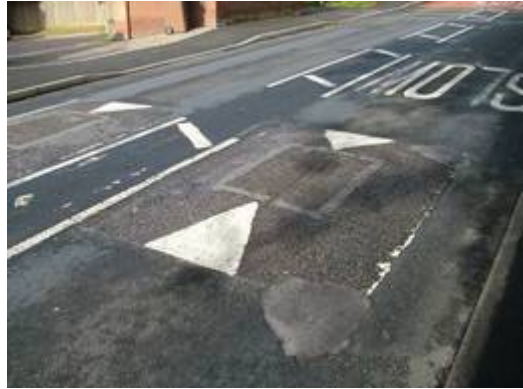
Located approximately 65 metres west of Site 4 in East Dale Road. The southern cushion measures 2.9 metres long by 2.1 metres wide with a maximum upstand of 112mm and the northern cushion measures 3.0 metres long by 2.1 metres wide with a maximum upstand of 85 mm and the gap between the two cushions is 1.2 metres. The gap between the southern footway and the southern cushion is 0.9 metres and the gap between the northern footway and the northern cushion is 1.1 metres. The kerb height of the southern footway is 140 mm and the northern footway is 100 mm.

February 2012 condition survey comments: [Eroded edge replace northern.](#)

October 2012 condition survey comments: [Replace both speed cushions.](#)

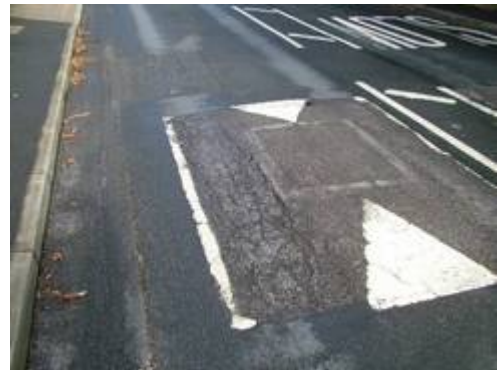
Located approximately 55 metres west of Site 5. The southern cushion measures 2.9 metres long by 2.1 metres wide with a maximum upstand of 120 mm and the northern cushion measures 3.1 metres long by 2.1 metres wide with a maximum upstand of 115 mm and the gap between the two cushions is 1.3 metres. The gap between the southern footway and the southern cushion is 0.9 metres and the gap between the northern footway and the northern cushion is 1.1 metres. The kerb height of the southern footway is 75 mm and the northern footway is 100 mm.

February 2012 condition survey comments: [Eroded edges replace both.](#)

October 2012 condition survey comments: [Replace both speed cushions.](#)

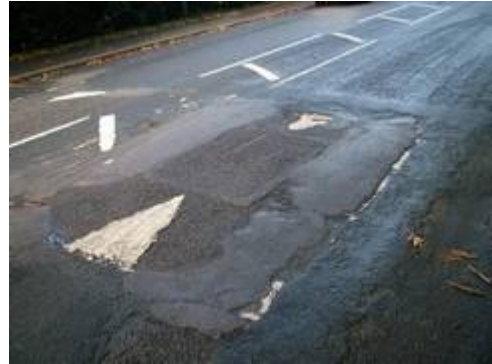
Located approximately 120 metres west of Site 6. The southern cushion measures 2.9 metres long by 1.9 metres wide with a maximum upstand of 120 mm and the northern cushion measures 3.1 metres long by 2.1 metres wide with a maximum upstand of 115 mm and the gap between the two cushions is 1.2 metres. The gap between the southern footway and the southern cushion is 1.3 metres and the gap between the northern footway and the northern cushion is 1.1 metres. The kerb height of the southern footway is 75 mm and the northern footway is 100 mm.

February 2012 condition survey comments: Replace both and 1 metre around perimeter.

October 2012 condition survey comments: Replace both speed cushions and 1 metre around perimeter.

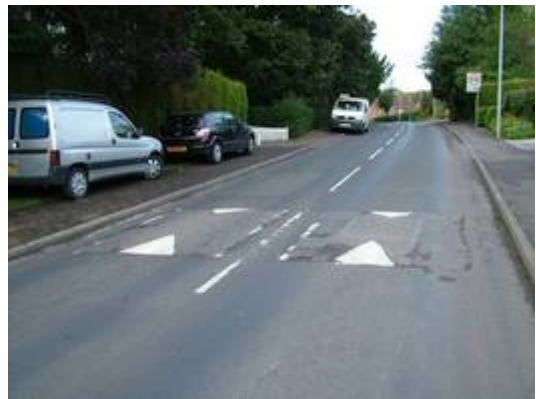
Located approximately 185 metres west of Site 7. The southern cushion measures 2.9 metres long by 2.0 metres wide with a maximum upstand of 190 mm and the northern cushion measures 2.9 metres long by 2.1 metres wide with a maximum upstand of 50 mm and the gap between the two cushions is 0.7 metres. The gap between the southern footway and the southern cushion is 0.7 metres and the gap between the northern footway and the northern cushion is 0.7 metres. The kerb height of the southern footway is 60 mm and the northern footway is 110 mm.

February 2012 condition survey comments: Eroded edges replace both.

October 2012 condition survey comments: Replace both speed cushions.

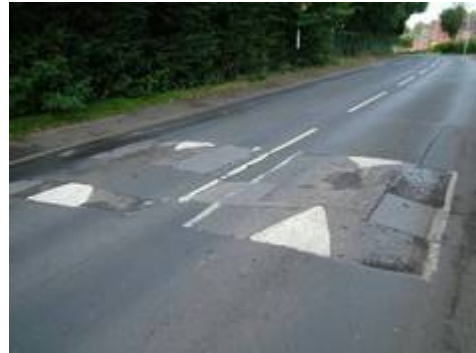
Located approximately 35 metres west of Site 8. The southern cushion measures 2.9 metres long by 2.0 metres wide with a maximum upstand of 90 mm and the northern cushion measures 2.9 metres long by 1.9 metres wide with a maximum upstand of 135 mm and the gap between the two cushions is 0.6 metres. The gap between the southern footway and the southern cushion is 0.7 metres and the gap between the northern footway and the northern cushion is 0.7 metres. The kerb height of the southern footway is 60 mm and the northern footway is 110 mm.

February 2012 condition survey comments: [Eroded edges replace both.](#)

October 2012 condition survey comments: [Replace both speed cushions.](#)

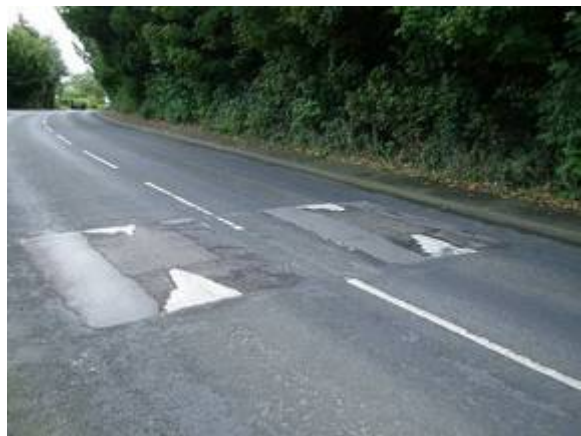
Located approximately 75 metres west of Site 9. The southern cushion measures 3.0 metres long by 2.0 metres wide with a maximum upstand of 110 mm and the northern cushion measures 3.0 metres long by 2.0 metres wide with a maximum upstand of 90 mm and the gap between the two cushions is 0.9 metres. The gap between the southern footway and the southern cushion is 0.8 metres and the gap between the northern footway and the northern cushion is 0.8 metres. The kerb height of the southern footway is 90 mm and the northern footway is 150 mm.

February 2012 condition survey comments: [Eroded edges replace both.](#)

October 2012 condition survey comments: [Replace both speed cushions.](#)

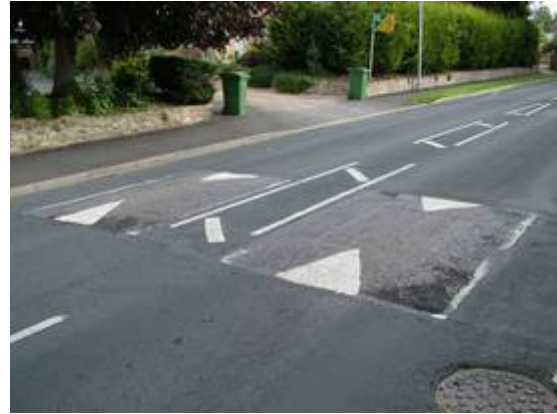
Located approximately 95 metres west of Site 10. The southern cushion measures 2.9 metres long by 2.1 metres wide with a maximum upstand of 95 mm and the northern cushion measures 2.9 metres long by 2.1 metres wide with a maximum upstand of 85 mm and the gap between the two cushions is 1.3 metres. The gap between the southern footway and the southern cushion is 1.0 metres and the gap between the northern footway and the northern cushion is 1.0 metres. The kerb height of the southern footway is 90 mm and the northern footway is 100 mm.

February 2012 condition survey comments: [Eroded edges replace both.](#)

October 2012 condition survey comments: [Replace both speed cushions.](#)

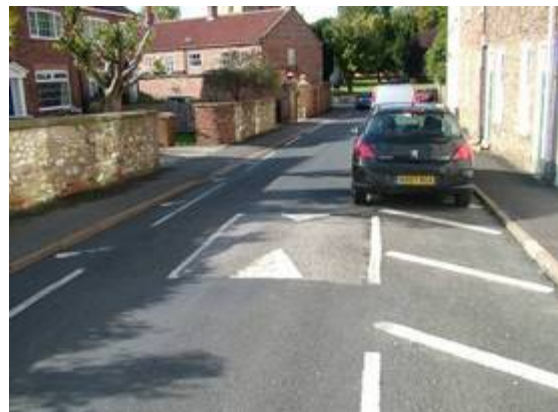
Located approximately 95 metres west of Site 11. There is a single speed cushion at this site, measuring 2.9 metres long by 1.8 metres wide with a maximum upstand of 90 mm. The gap between the eastern footway and the cushion is 1.7 metres and the gap between the western footway and the cushion is 1.6 metres.

The kerb height of the western footway is 100 mm and the eastern footway is 75 mm.

February 2012 condition survey comments: [OK](#).

October 2012 condition survey comments: [Western side eroded, replace \(In different position\)](#).

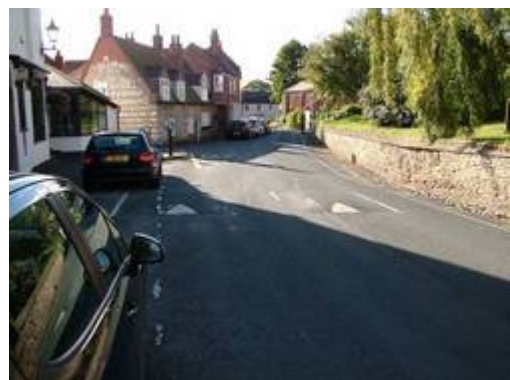
Located approximately 80 metres northwest of Site 12 in Ladywell Gate. The southern cushion measures 2.9 metres long by 1.9 metres wide with a maximum upstand of 65 mm and the northern cushion measures 2.9 metres long by 2.0 metres wide with a maximum upstand of 110 mm and the gap between the two cushions is 1.4 metres. The gap between the southern footway and the southern cushion is 1.3 metres and the gap between the northern drainage channel and the northern cushion is 1.4 metres. The kerb height of the southern footway is 100 mm.

February 2012 condition survey comments: [OK renew lines only.](#)

October 2012 condition survey comments: [The speed cushions should be replaced.](#)

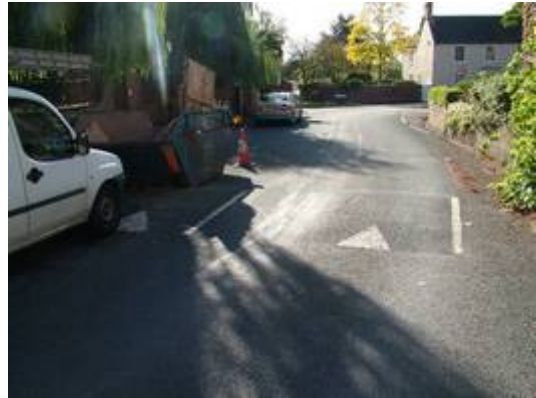
Located approximately 60 metres west of Site 13. The southern cushion measures 2.9 metres long by 1.9 metres wide with a maximum upstand of 70 mm and the northern cushion measures 2.9 metres long by 1.9 metres wide with a maximum upstand of 95 mm and the gap between the two cushions is 0.9 metres. The gap between the southern footway and the southern cushion is 0.8 metres and the gap between the northern footway and the northern cushion is 0.9 metres. The kerb height of the southern footway is 30 mm and the northern footway is 25 mm.

February 2012 condition survey comments: [OK renew lines only.](#)

October 2012 condition survey comments: [Edge of northern speed cushion eroded, replace.](#)

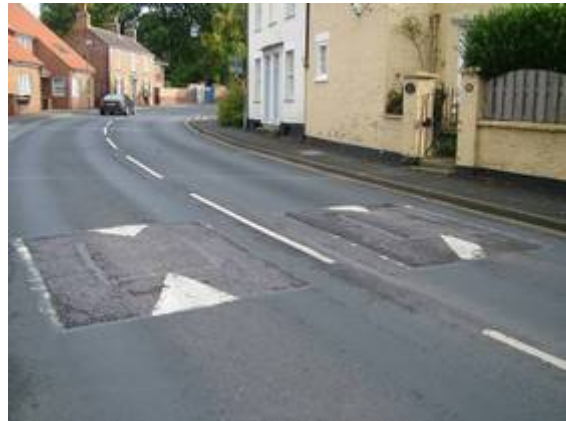
Located approximately 60 metres north of Site 17. The eastern cushion measures 2.9 metres long by 2.0 metres wide with a maximum upstand of 100 mm and the western cushion measures 2.9 metres long by 2.1 metres wide with a maximum upstand of 90 mm and the gap between the two cushions is 1.3 metres. The gap between the

eastern footway and the eastern cushion is 1.1 metres and the gap between the western footway and the western cushion is 1.1 metres. The kerb height of the western footway is 80 mm and the eastern footway is 90 mm.

February 2012 condition survey comments: [Replace eastern only.](#)

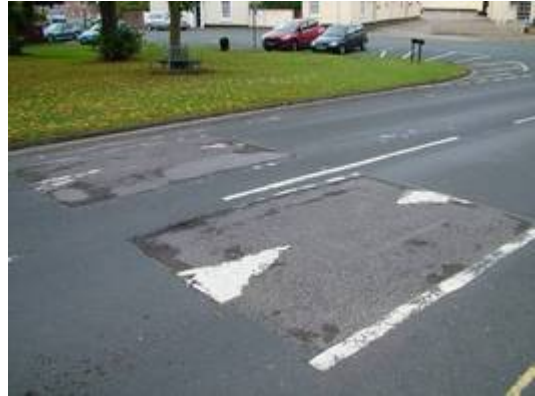
Located approximately 60 metres east of Site 15. The southern cushion measures 3.0 metres long by 2.1 metres wide with a maximum upstand of 115 mm and the northern cushion measures 3.1 metres long by 1.9 metres wide with a maximum upstand of 65 mm and the gap between the two cushions is 1.1 metres. The gap between the southern footway and the southern cushion is 1.2 metres and the gap between the northern footway and the northern cushion is 1.2 metres. The kerb height of the southern footway is 115 mm and the northern footway is 125 mm.

February 2012 condition survey comments: [Replace both.](#)

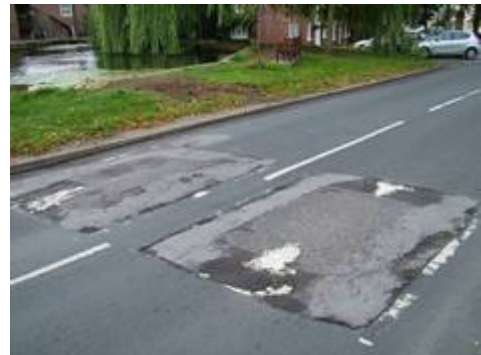
Located approximately 50 metres east of Site 18. The southern cushion measures 3.0 metres long by 2.1 metres wide with a maximum upstand of 65 mm and the northern cushion measures 2.9 metres long by 2.0 metres wide with a maximum upstand of 115 mm and the gap between the two cushions is 0.7 metres. The gap between the southern footway and the southern cushion is 0.6 metres and the gap between the northern footway and the northern cushion is 0.7 metres. The kerb height of the southern footway is 120 mm and the northern footway is 75 mm.

February 2012 condition survey comments: [Replace both cushions.](#)

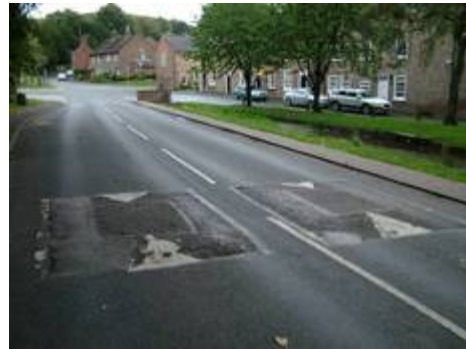
Located approximately 120 metres east of Site 19. The southern cushion measures 2.9 metres long by 2.1 metres wide with a maximum upstand of 70 mm and the northern cushion measures 2.9 metres long by 2.1 metres wide with a maximum upstand of 85 mm and the gap between the two cushions is 0.9 metres. The gap between the southern footway and the southern cushion is 0.8 metres and the gap between the northern footway and the northern cushion is 0.8 metres. The kerb height of the southern footway is 70 mm and the northern footway is 75 mm.

February 2012 condition survey comments: [Replace northern only.](#)

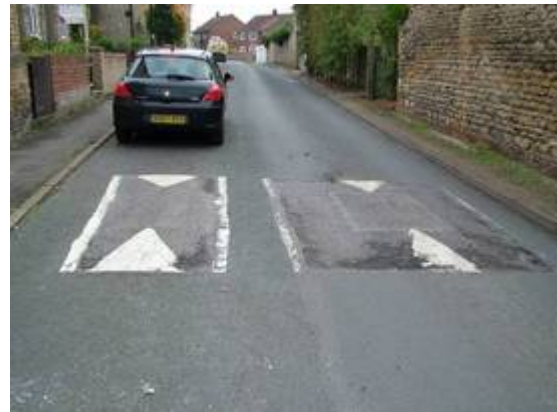
Located approximately 60 metres north of Site 22, and 35 metres south of the Cowgate / Kidd Lane junction. The western cushion measures 3.1 metres long by 2.1 metres wide with a maximum upstand of 130 mm and the eastern cushion measures 3.1 metres long by 1.1 metres wide with a maximum upstand of 40 mm and the gap between the two cushions is 0.7 metres. The gap between the eastern footway and the eastern cushion is 0.7 metres and the gap between the western footway and the western cushion is 0.7 metres. The kerb height of the western footway is 125 mm and the eastern footway is 30 mm. There are two arrow markings on the cushions, incorrectly indicating two-way traffic.

February 2012 condition survey comments: [Replace full \(larger\) cushion only.](#)

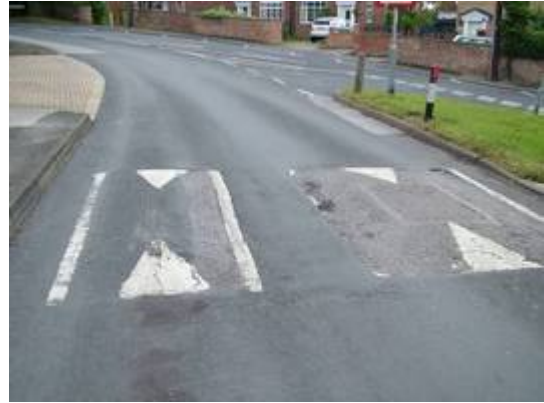
Located approximately 60 metres south of Site 21, and 20 metres north of the Ladywell Gate / Welton Old Road junction. The western cushion measures 3.0 metres long by 2.0 metres wide with a maximum upstand of 105 mm and the eastern cushion measures 2.9 metres long by 1.2 metres wide with a maximum upstand of 35 mm and the gap between the two cushions is 0.8 metres.

The gap between the eastern footway and the eastern cushion is 0.5 metres and the gap between the western footway and the western cushion is 0.7 metres. The kerb height of the western footway is 30 mm and the eastern footway is 180 mm. There are two arrow markings on the cushions, incorrectly indicating two-way traffic.

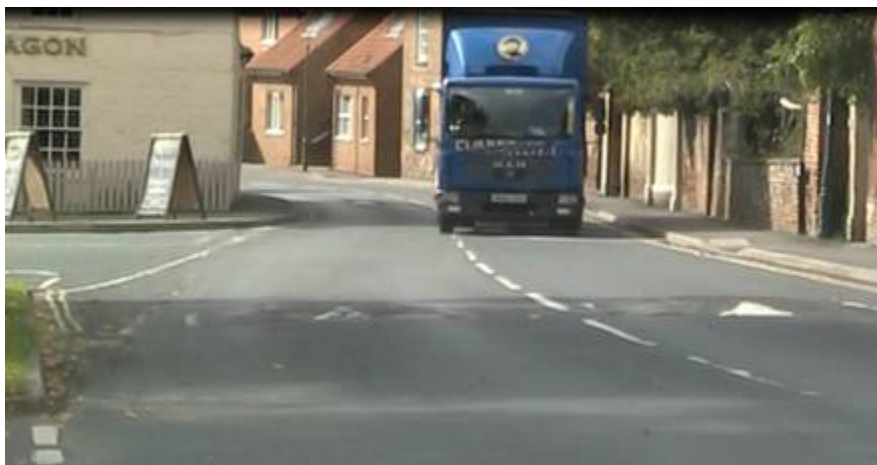
Pulling out to miss tree 26mph

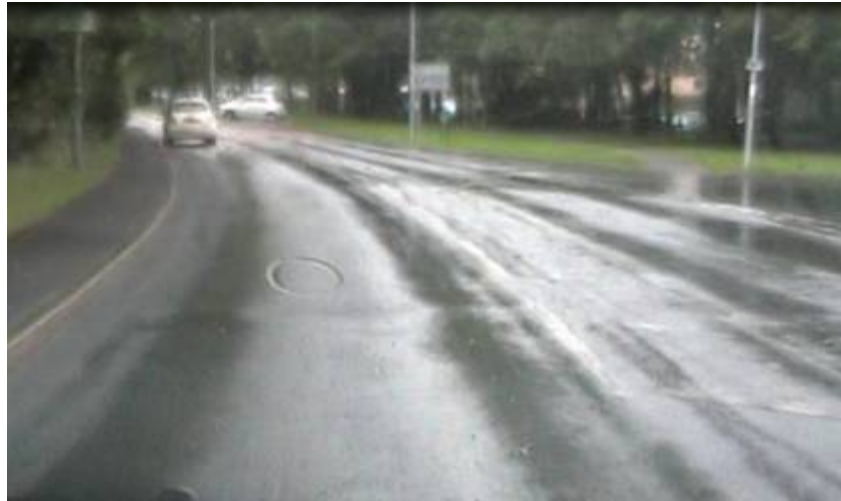
Parked on bend

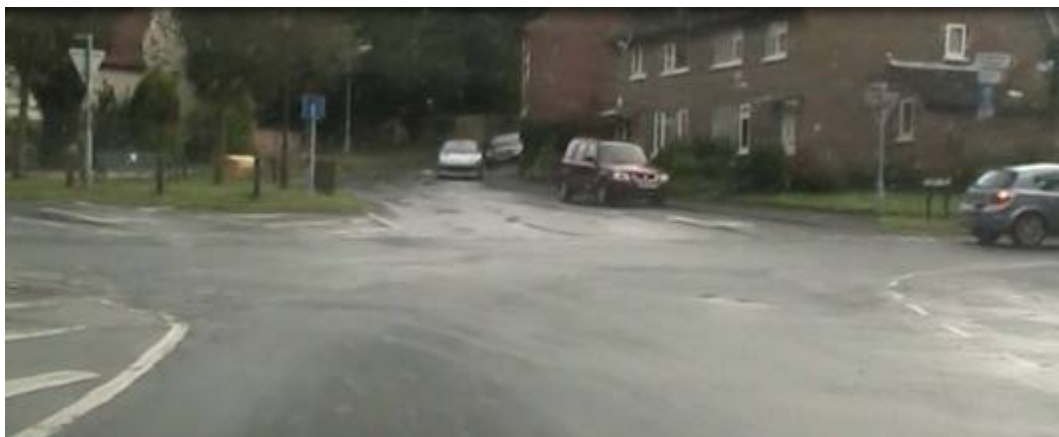
Reversing out of one-way street

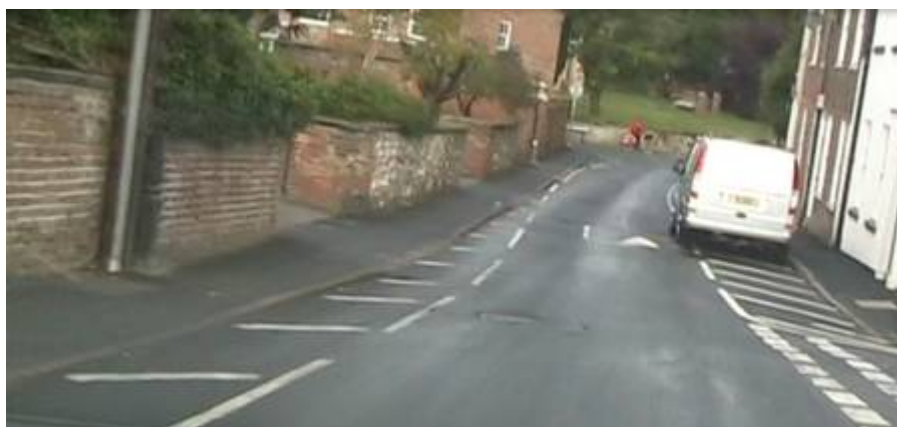
Cyclist going wrong way

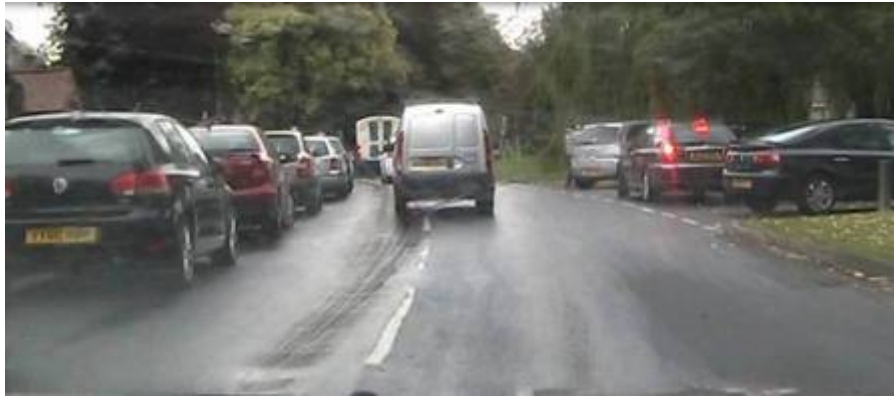
Signal head masked from further back humps for 3/4 mile sign hidden

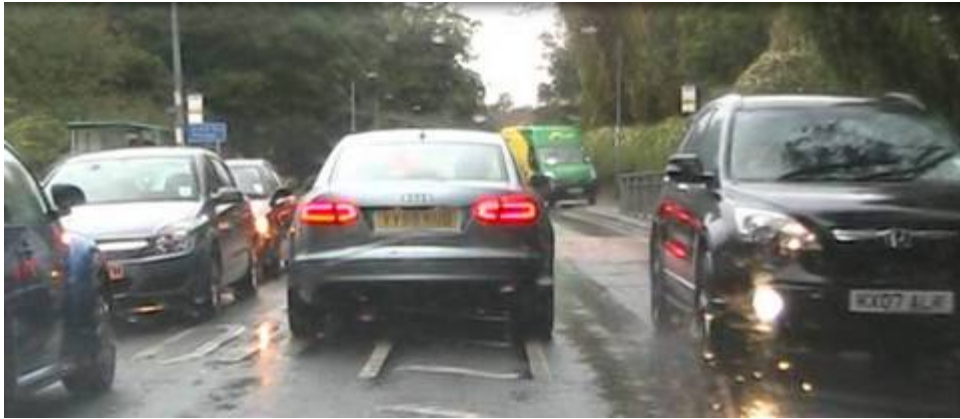
Van turning right from In access road and mounting footway
