# **Traffic Calming, Welton and Melton, East Riding of Yorkshire**

## **Final Report**

19<sup>th</sup> December 2012

### **CA Traffic Solutions LLP**

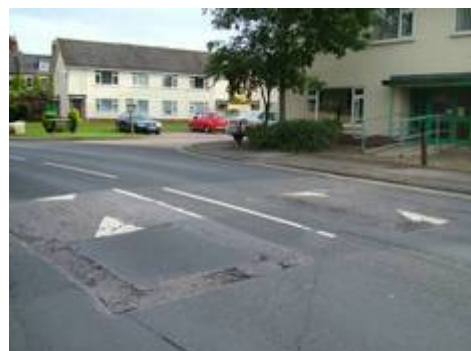
#### 5.6.7.1 Site 17

Located approximately 110 metres north of the Welton Road junction. The eastern cushion measures 2.9 metres long by 2.1 metres wide with a maximum upstand of 45 mm and the western cushion measures 2.9 metres long by 2.2 metres wide with a maximum upstand of 135 mm and the gap between the two cushions is 1.3 metres. The gap between the eastern footway and the eastern cushion is 1.4 metres and the gap between the western footway and the western cushion is

1.5 metres. The kerb height of the western footway is 100 mm and the eastern footway is 125 mm.

February 2012 condition survey comments: [Replace eastern only plus patch to north side approach.](#)

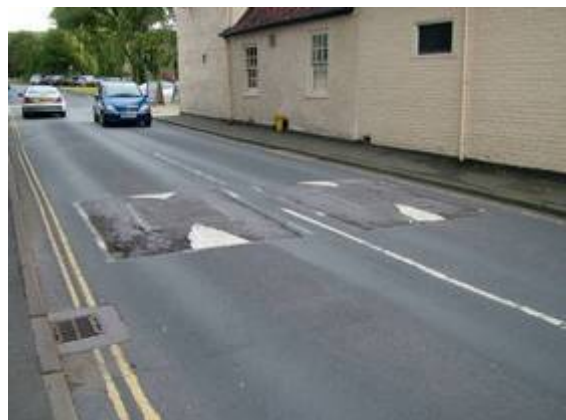
#### 5.6.7.3 Site 15

Located approximately 70 metres north of Site 16. The southern cushion measures 3.1 metres long by 2.1 metres wide with a maximum upstand of 75 mm and the northern cushion measures 2.9 metres long by 2.1 metres wide with a maximum upstand of 80 mm and the gap between the two cushions is 0.6 metres. The gap between the

southern footway and the southern cushion is 0.7 metres and the gap between the northern footway and the northern cushion is 0.8 metres. The

kerb height of the southern footway is 90 mm and the northern footway is 100 mm.

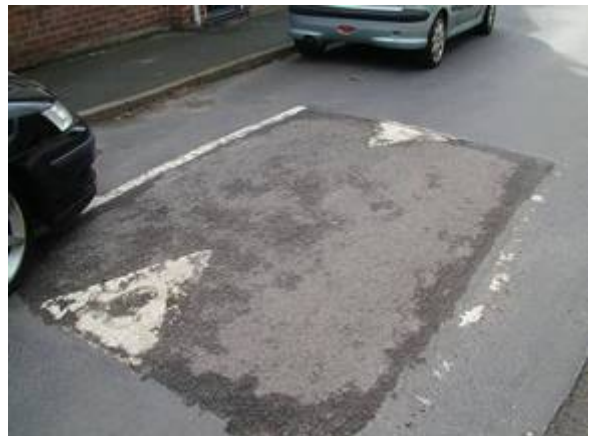
#### 5.9.6.1 Site 23

Located approximately 100 metres east of Site 20 and approximately 35 metres northeast of the Parliament Street junction. There is a single speed cushion at this site, measuring 2.9 metres long by 2.1 metres wide with a maximum upstand of 75 mm. The gap between the southern footway and the cushion is 1.4 metres and the gap between the northern verge and the cushion is 1.5 metres. The kerb height of the southern footway is 90 mm.

February 2012 condition survey comments: [Not included in survey.](#)

October 2012 condition survey comments: [The cushion should be replaced.](#)

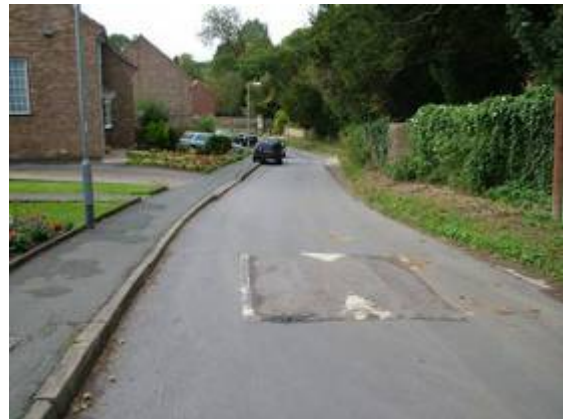
#### 5.9.6.2 **Site 24**

Located approximately 60 metres east of Site 23. There is a single speed cushion at this site, measuring 2.8 metres long by 2.1 metres wide with a maximum upstand of 95 mm. The gap between the southern footway and the cushion is 1.2 metres and the gap between the northern verge and the cushion is 1.2 metres. The kerb height of the southern footway is 100 mm.

February 2012 condition survey comments: [Not included in survey.](#)

October 2012 condition survey comments: [The cushion should be replaced.](#)

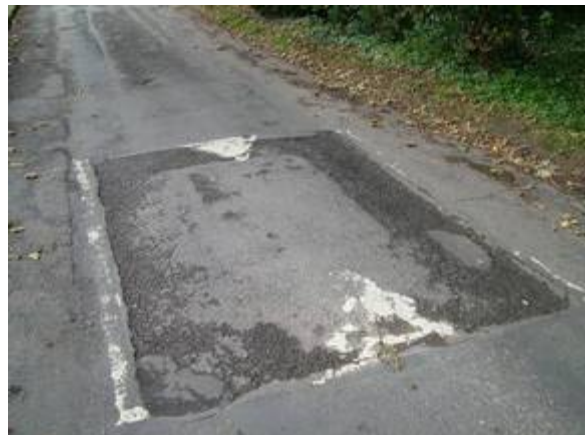
#### 5.9.6.3 **Site 25**

Located approximately 60 metres east of Site 24, and approximately 35 metres from the speed limit terminal sign at the Holly Hill junction. There is a single speed cushion at this site, measuring 2.9 metres long by 2.2 metres wide with a maximum upstand of 80 mm. The gap between the southern footway and the cushion is 0.8 metres and the gap between the northern verge and the cushion is 1.1 metres. The kerb height of the southern footway is 100 mm.

February 2012 condition survey comments: [Not included in survey.](#)

October 2012 condition survey comments: [The cushion should be replaced.](#)

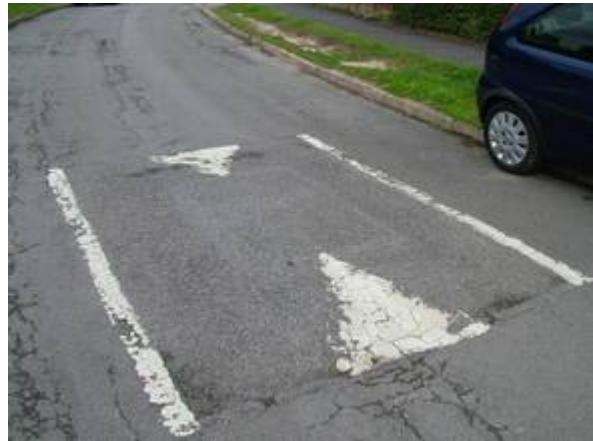
#### **5.10.6.1 Site 26**

Located approximately 45 metres south of the Chapel Hill junction. There is a single speed cushion at this site, measuring 3.1 metres long by 2.1 metres wide with a maximum upstand of 70 mm. The gap between the western footway and the cushion is 1.5 metres and the gap between the eastern footway and the cushion is 1.6 metres. The kerb height of the western footway is 100 mm and the kerb height of the eastern footway is 110 mm.

February 2012 condition survey comments: [Not included in survey.](#)

October 2012 condition survey comments: [The cushion should be replaced.](#)

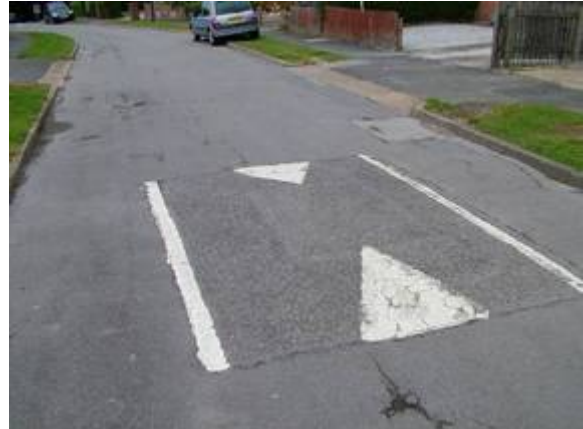
#### 5.10.6.2 **Site 27**

Located approximately 45 metres south of Site 26. There is a single speed cushion at this site, measuring 3.0 metres long by 2.2 metres wide with a maximum upstand of 100 mm. The gap between the eastern footway and the cushion is 1.3 metres and the gap between the western footway and the cushion is 1.3 metres. The kerb height of the western footway is 80 mm and the eastern footway is 100 mm.

February 2012 condition survey comments: [Not included in survey.](#)

October 2012 condition survey comments: [Carriageway markings need renewing.](#)

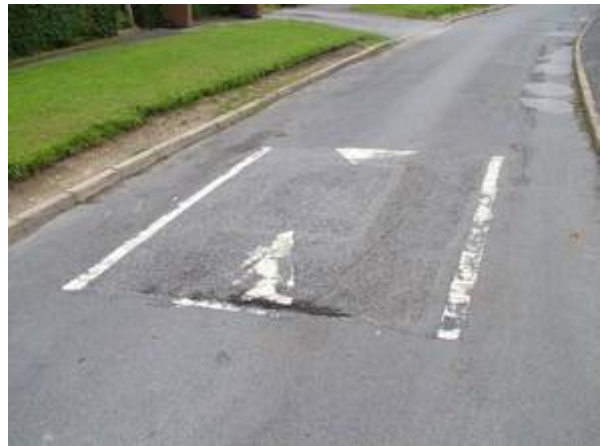
#### 5.10.6.3 **Site 28**

Located approximately 65 metres south of Site 27 and approximately 65 metres north of Welton Old Road junction. There is a single speed cushion at this site, measuring 2.9 metres long by 2.2 metres wide with a maximum upstand of 85 mm. The gap between the eastern footway and the cushion is 1.3 metres and the gap between the western footway and the cushion is 1.3 metres. The kerb height of the western footway is 60 mm and the eastern footway is 75 mm.

February 2012 condition survey comments: [Not included in survey.](#)

October 2012 condition survey comments: [The cushion should be replaced.](#)

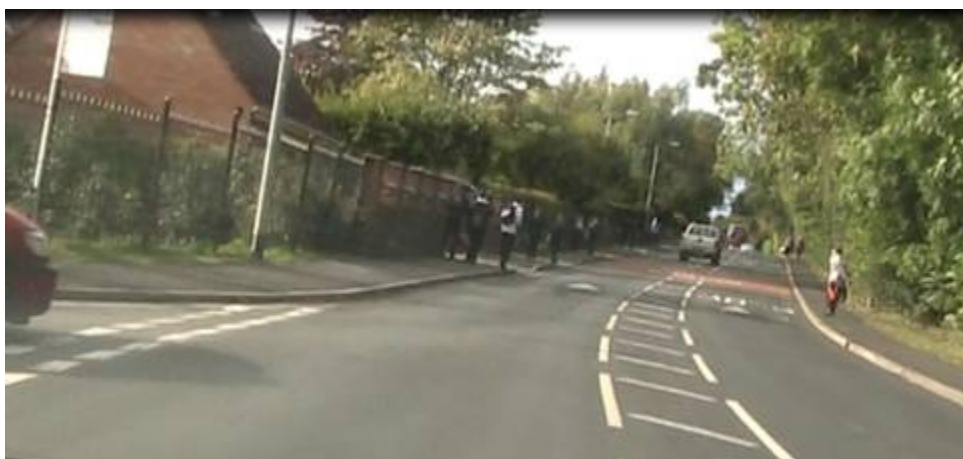
Tree overhanging footway

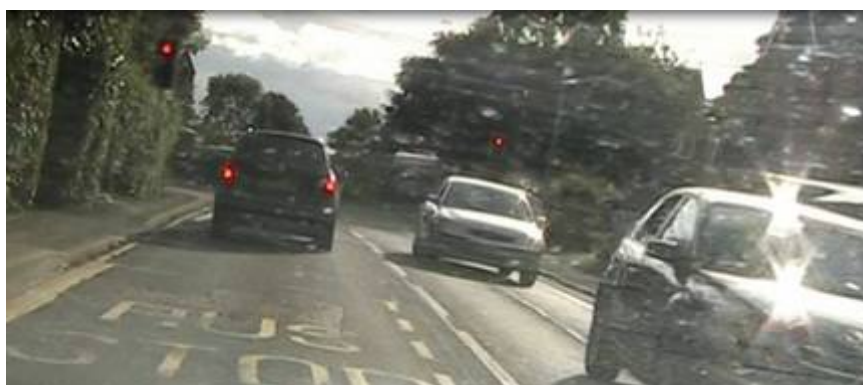
Signal head masked from further back humps for 3/4 mile sign hidden

- iii) All regulatory and warning signs should be clearly visible to approaching drivers;
- iv) Remedial works should be undertaken in Chapel Hill to remove the potential hazards created by the protruding iron work and concrete block;

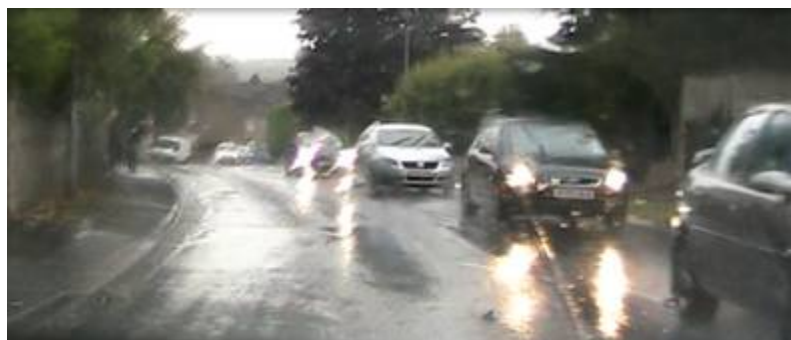
Platoons of vehicles at end of school day

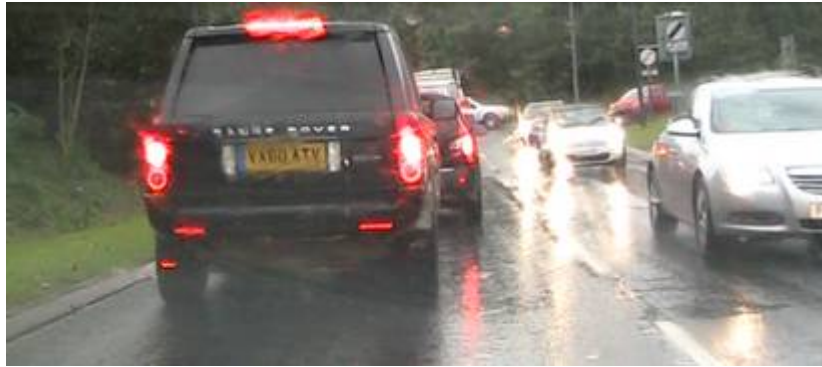
Rat running ??
